Emma's HIF4 Carburettor Problems and Solutions:

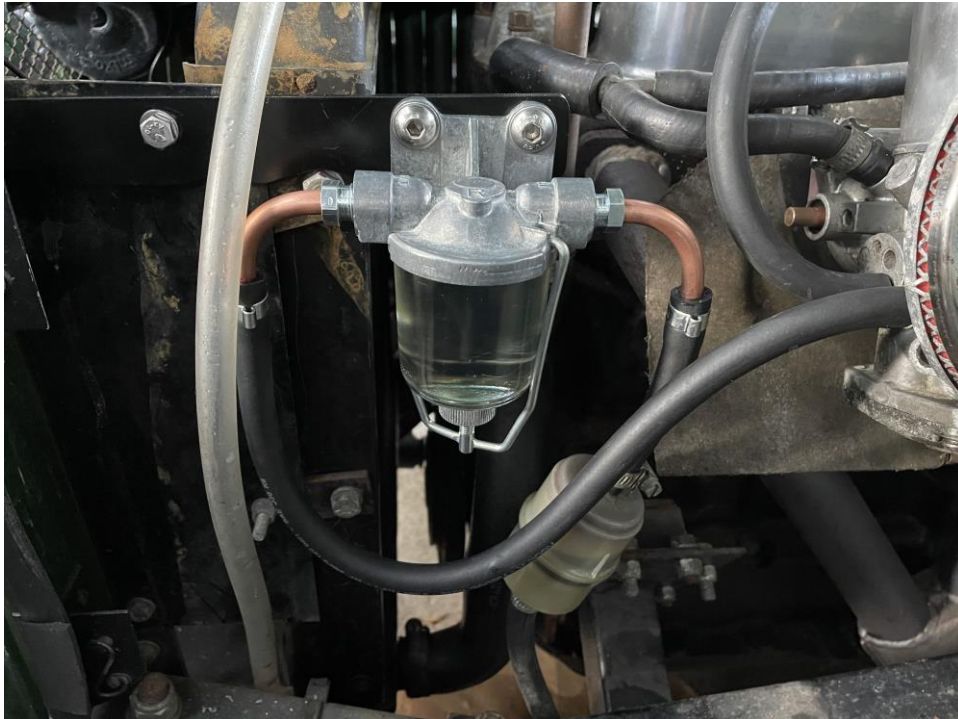
↑ The AC Delco Water Filter / Separator.

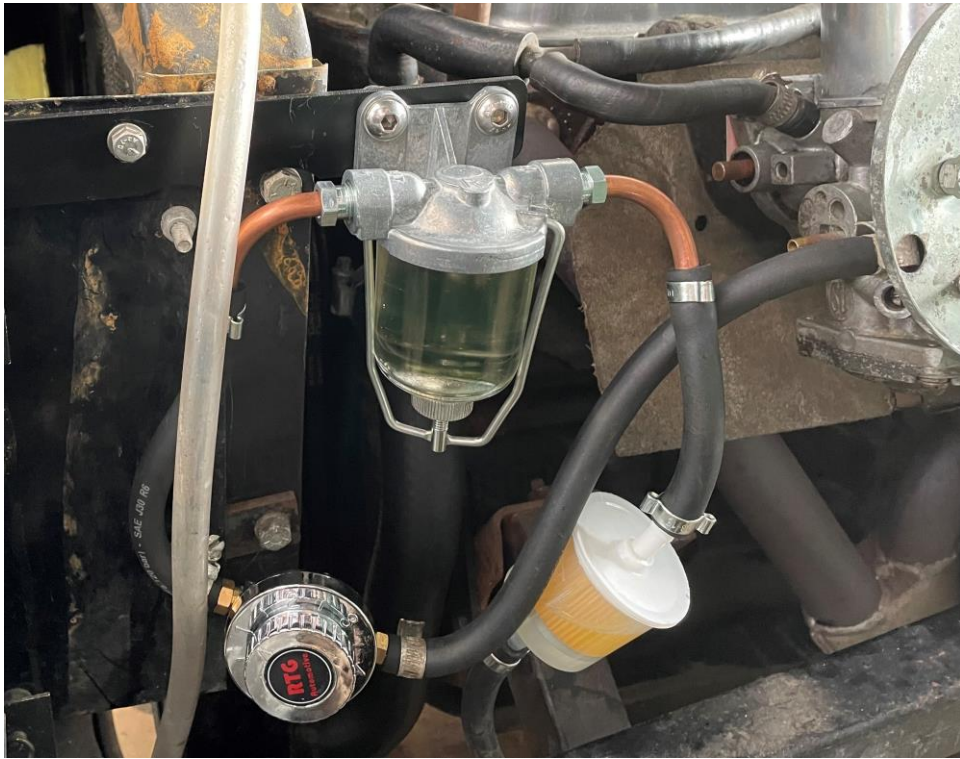
To test my theory in respect of high fuel pump pressure I blocked the fuel hose that goes to the front carburettor then got a six foot high step ladder, stood a can off Esso E5 on the top step, and jury rigged a gravity fuel feed to the front carb (where it passed to the rear carb). On turning the engine over no fuel came out of the rear carb overflow. After re-connecting the king-lead I started the engine and everything appeared to work as normal, again with no fuel coming out of the rear carb overflow. Several stop and start tests produced the same result. This test seemed to confirm my theory that the fuel pressure was too high for the replacement needle valve, so I spent another £25.99 and purchased a fuel pressure regulator that had a calibration dial reading between 1 and 5 psi in half psi increments. Selecting the lowest setting I plumbed it in the fuel line between the water separator and the front carburettor.

↑ The fuel pressure regulator.

Voila! Problem solved, and has remained solved ever since. Now I'm not naïve enough to think that I've rectified the fault, rather I've masked the symptoms. There must be something fundamentally wrong with that rear carburettor/needle valve (maybe it's just a faulty one that snuck past quality control) otherwise why doesn't the front carb produce the same symptoms. There is a fair amount of information on the internet about these HIF4 carbs leaking from the overflow, but no one has offered a solution other than dirty fuel, faulty needle valves and punctured floats; in other words the normal suspects, none of which appeared to apply to Emma.

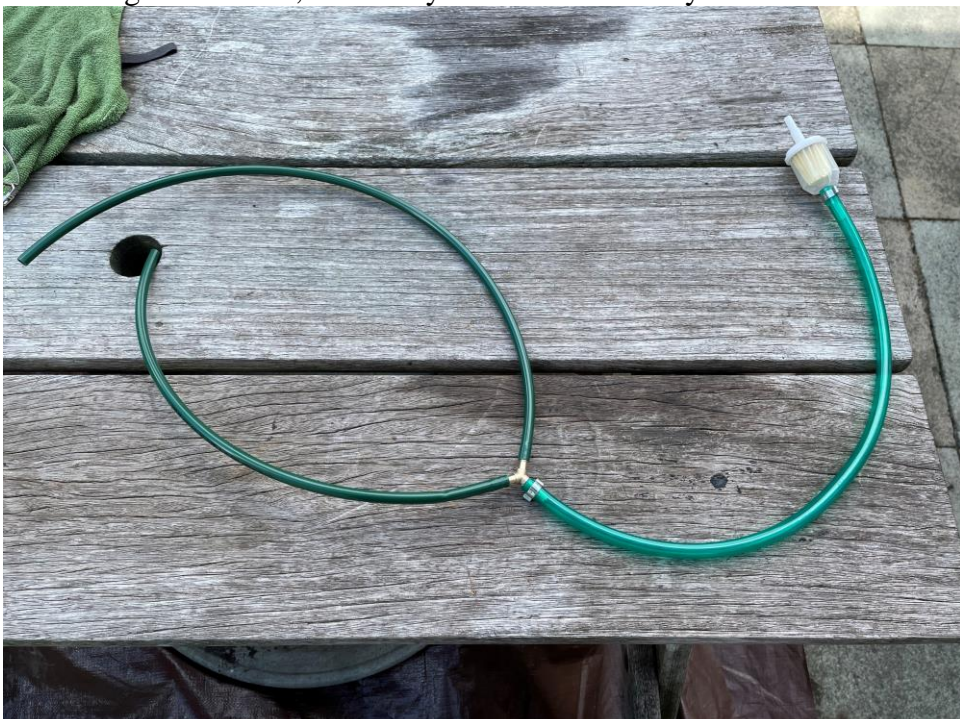
↑ The new overflow breather system.

To finish off I used some 6mm nylon pipe to form a breather system for the carb overflows, terminating them on the opposite side of the car to the exhaust system. I fitted a fuel filter (as shown in the photo) it's purpose is to act as an air filter and prevent crud getting into the carbs via the overflow tubes and to act as a connector for another short length of nylon pipe (I only had short lengths in my box of bits) which exits just below the chassis on the right hand side, well away from the exhaust system.
