Cracker's Bonnet Strengthening Strip:

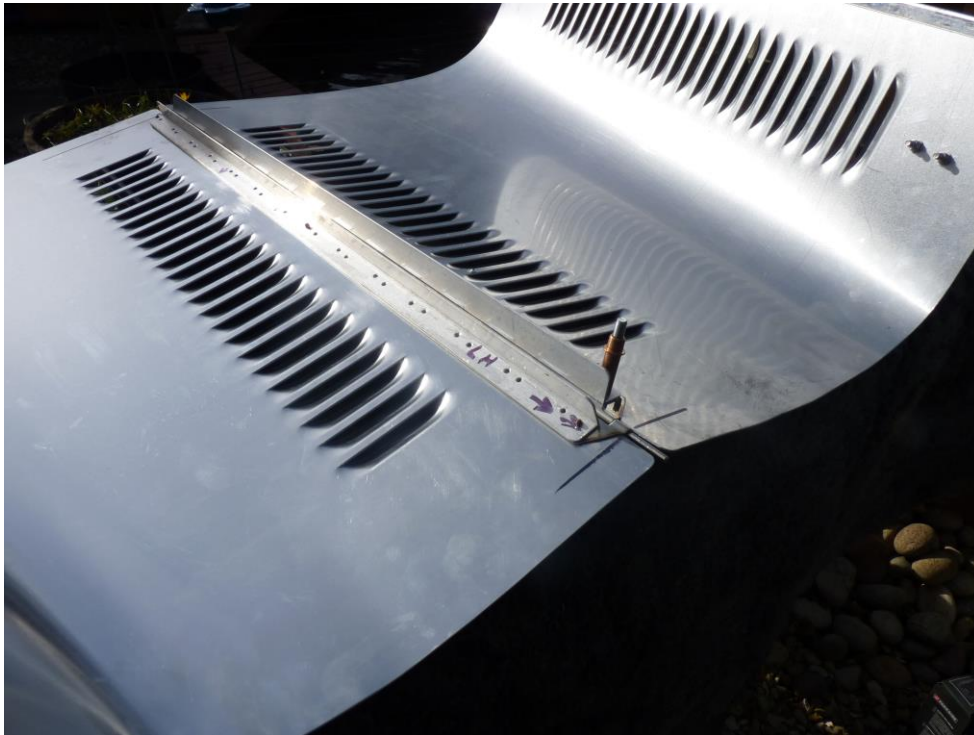
Kermit's two piece bonnet strengtheners.

Normally (as shown in the first photo above) I would fit the reinforcing strip with the corner towards the hinge pin but on my TC the sloping heater top was very close to the underside of the bonnet which meant

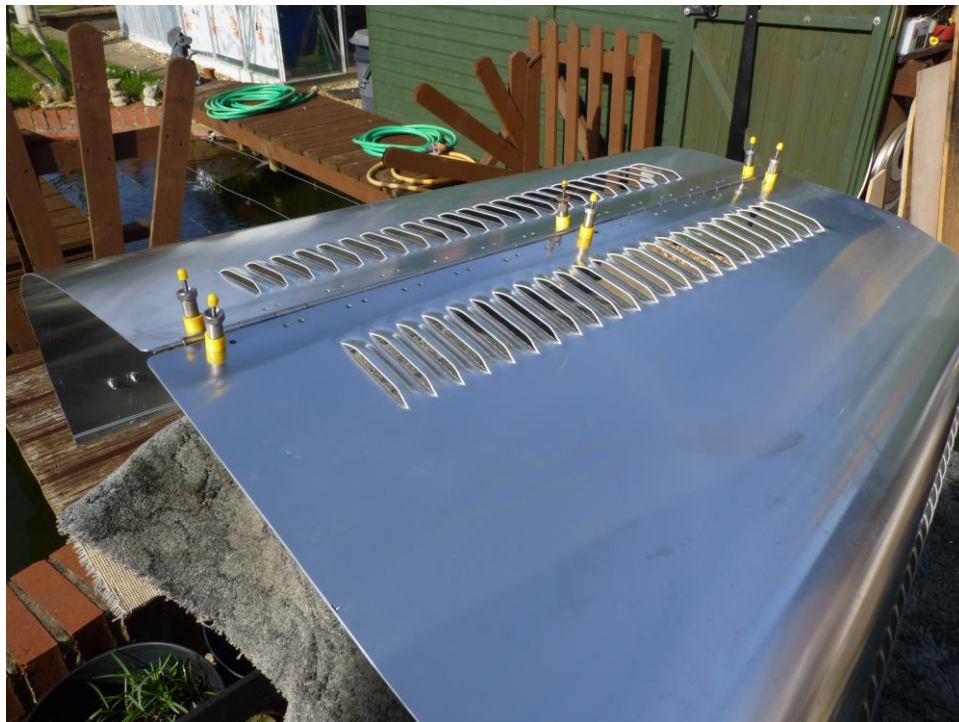
Ditto.

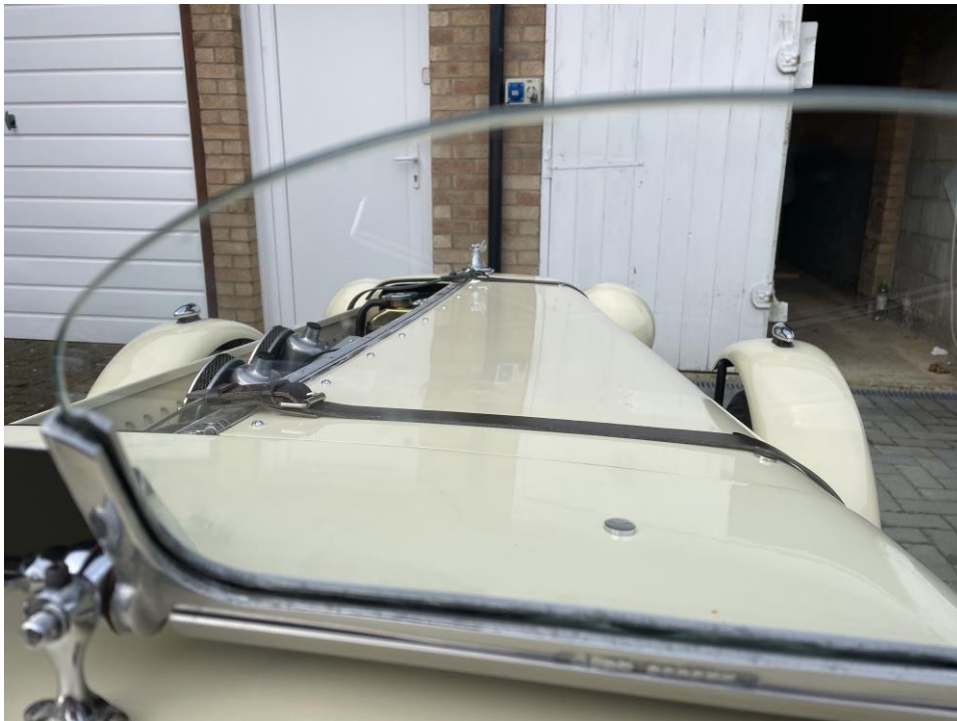
Unfortunately the photo doesn't indicate the full extent of the droop.

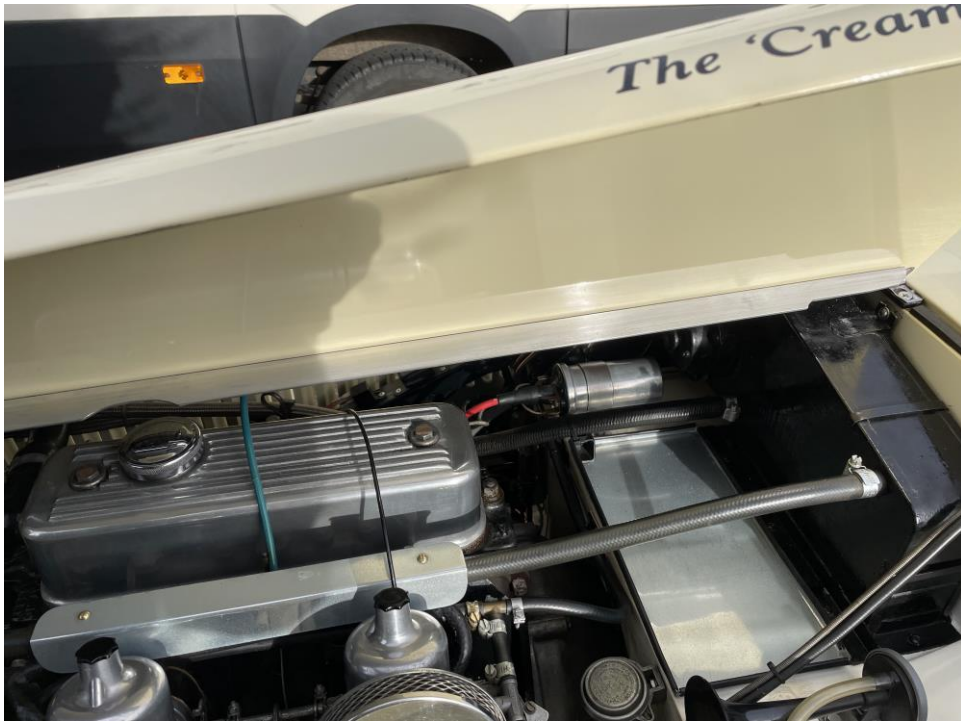
Aluminium equal angle cut of for heater and oil filler cap clearance.

that I would need to reduce the rear end of the strip too much to gain sufficient clearance. The corner was therefore positioned away from the hinge pin which reduced the amount needing to be cut off the equal angle, hence leaving it stronger.

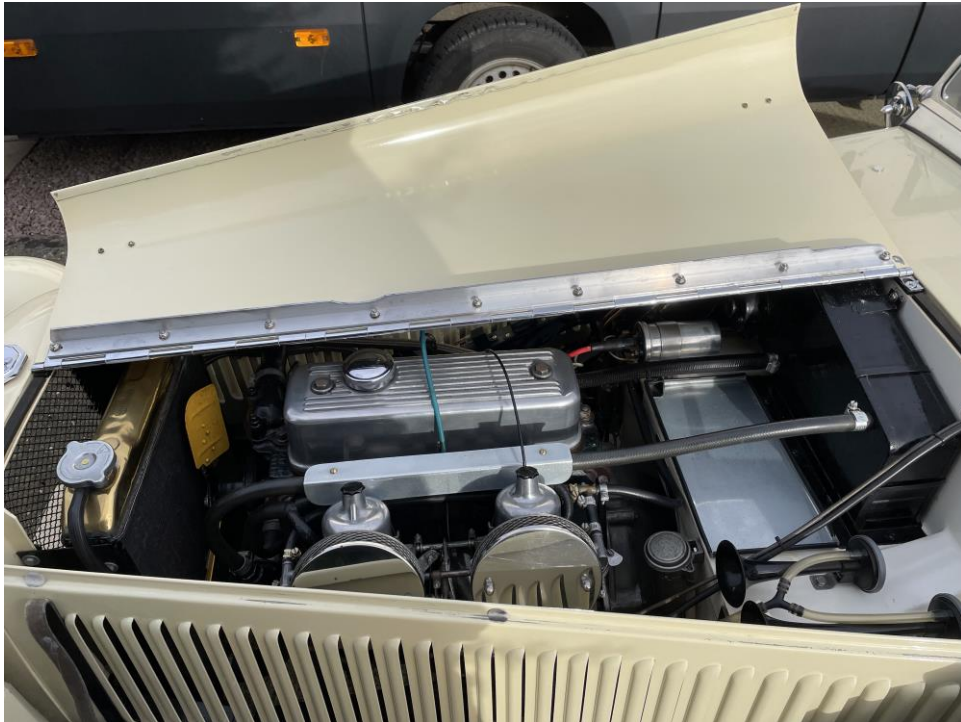
Ditto.

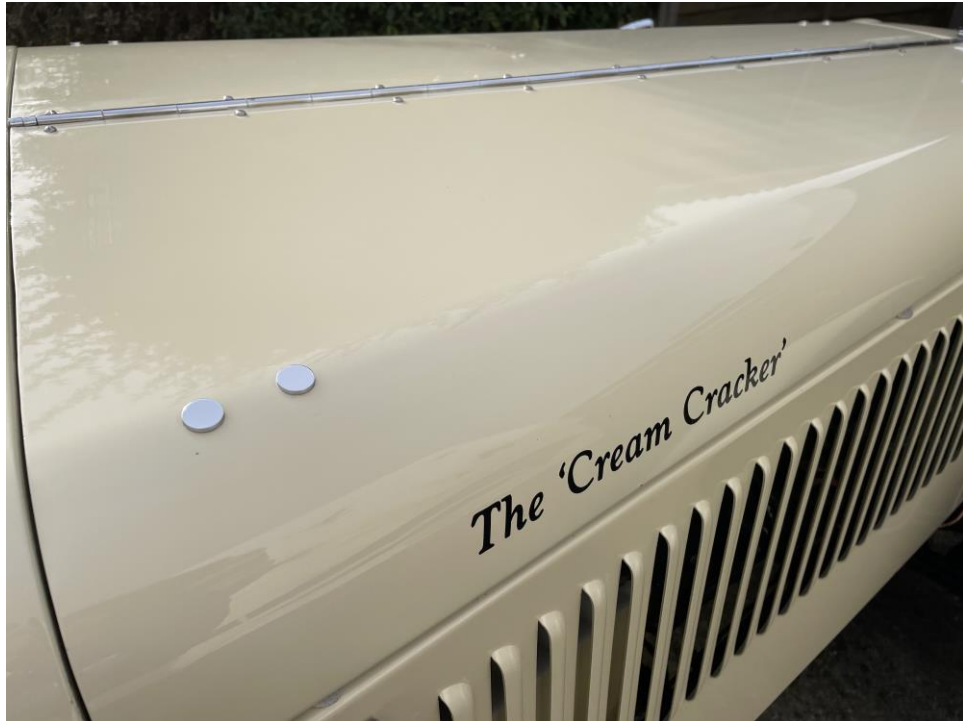
That's better.

It's nice to look down towards the radiator cowl and see a nice straight bonnet line. This is a small job that it well worth the effort on an older NG.
