Cracker's 'B' Series engine timing marks.

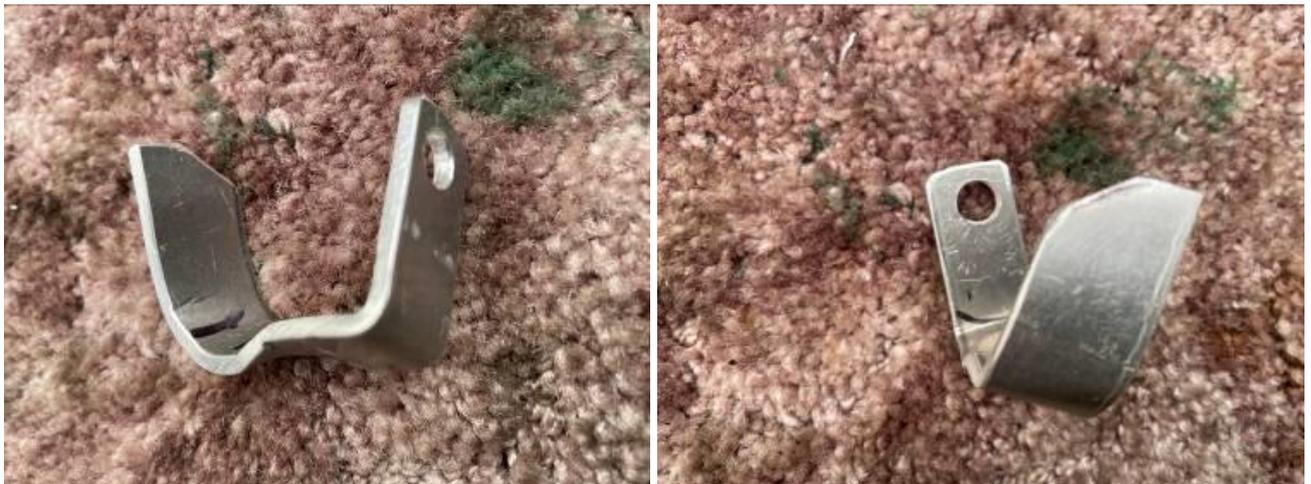
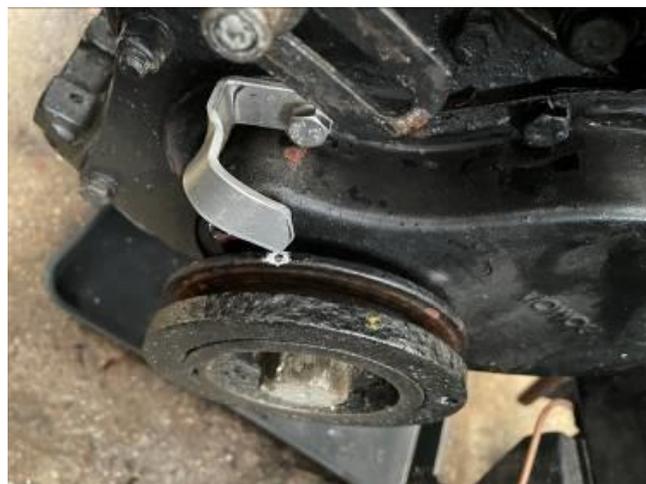
With the radiator out for flushing as part of the 2025/6 winters jobs I decided to improve on the welding wire pointer. The photos should be self explanatory.

After jacking him up and putting some blocks under the wheels I changed the contact breaker points and condenser etc. then set the timing from underneath, I thought I'm not doing that again, stopped the engine, set the crank to 14 degrees before TDC (Top Dead Centre) then bent up a bit of welding wire, trapped it under a timing bolt, drilled a small hole in the pulley and bent the welding wire so it pointed at the marked hole in the pulley. Last year after changing the points and condenser (which I tend to do every year regardless of mileage) I set his dynamic timing on the welding wire. No more grovelling underneath to set the timing.
