Cracker's False Luggage Floor: email

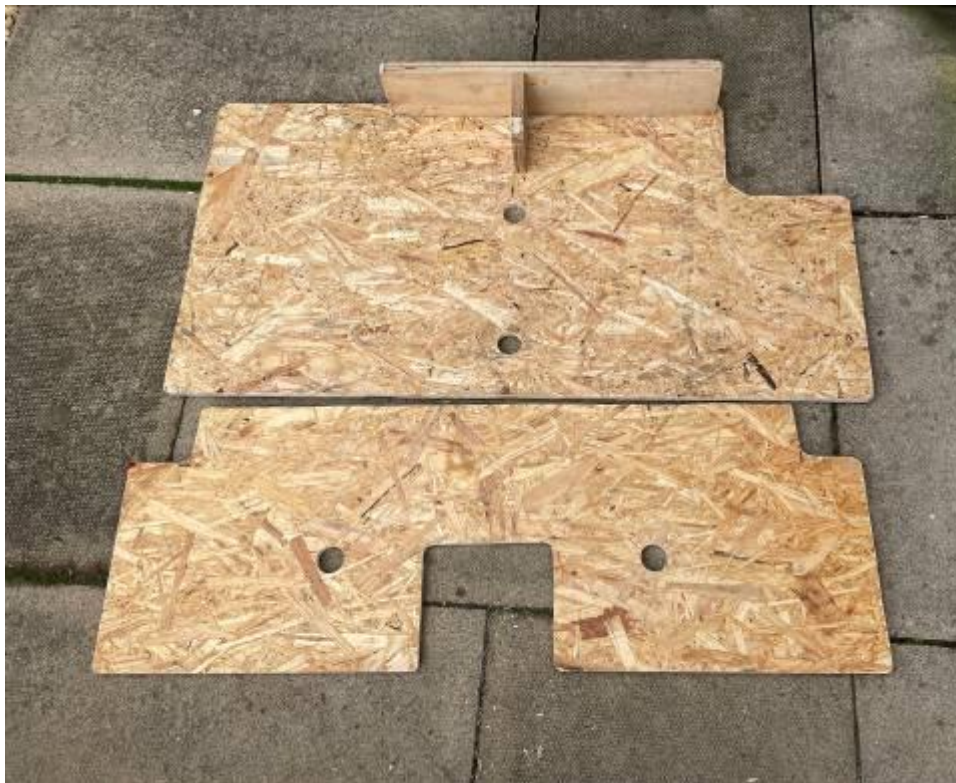
Originally I made the rear panel as per the photo below (with the support screwed to the panel) but it was very difficult to fit the panel in the confined space available, especially with the tools in place, hence the support shown was removed and modified to become a stand alone item.

Underside view of the panels as they were originally made.

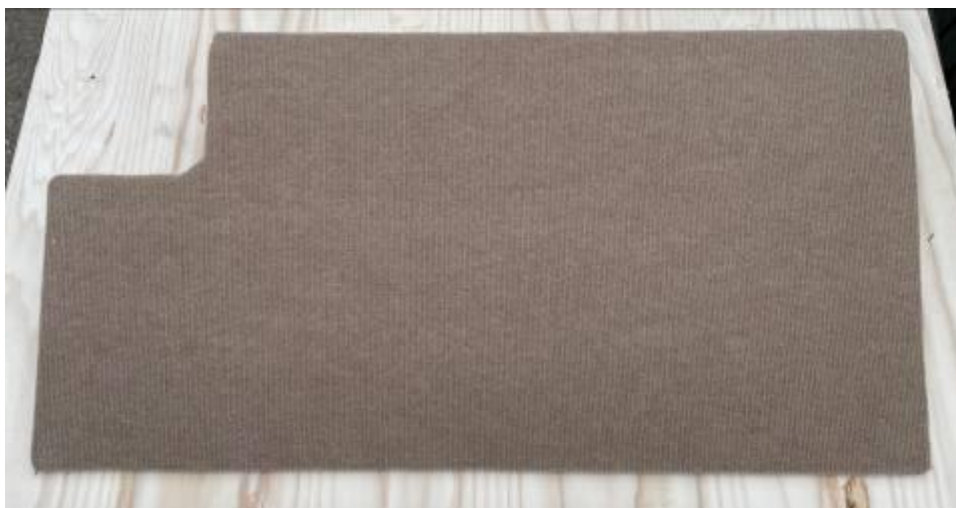
The photos below show the floor covered in lightweight carpet that was secured in place with No-Nonsense Contact Adhesive from Screwfix then stapled round the edge of the underside.

Rear board with corner cut-out for fuel filler pipe.

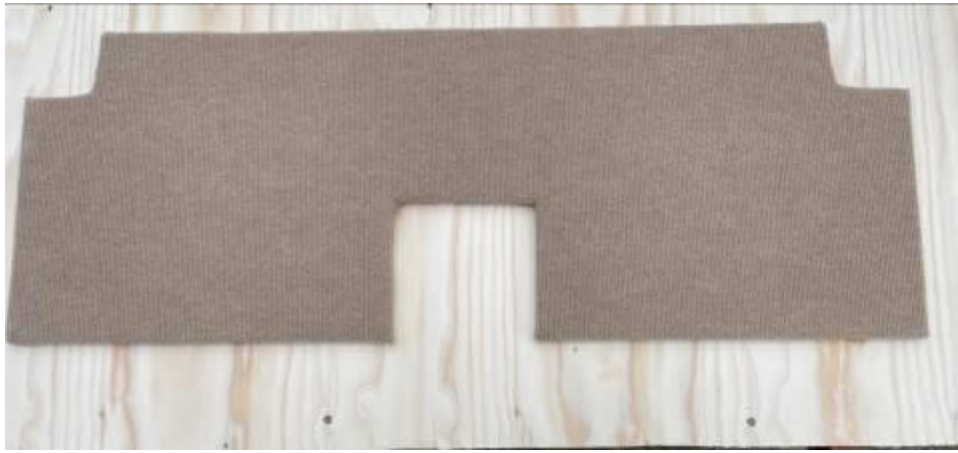
Front board cut out for seat belt brackets and body support brace.

To level the rear panel up a 1" thick strip of wood is screwed underneath and half an inch to the rear of its front edge. The rear edge of the front panel sits slightly under the front edge of the rear panel. The panels are covered by some light brown carpet (left over from a previous campervan build) which was the only bit of lightweight carpet I could find in the attic, it will eventually be changed to black to match the main carpet when I do a full carpet re-trim.

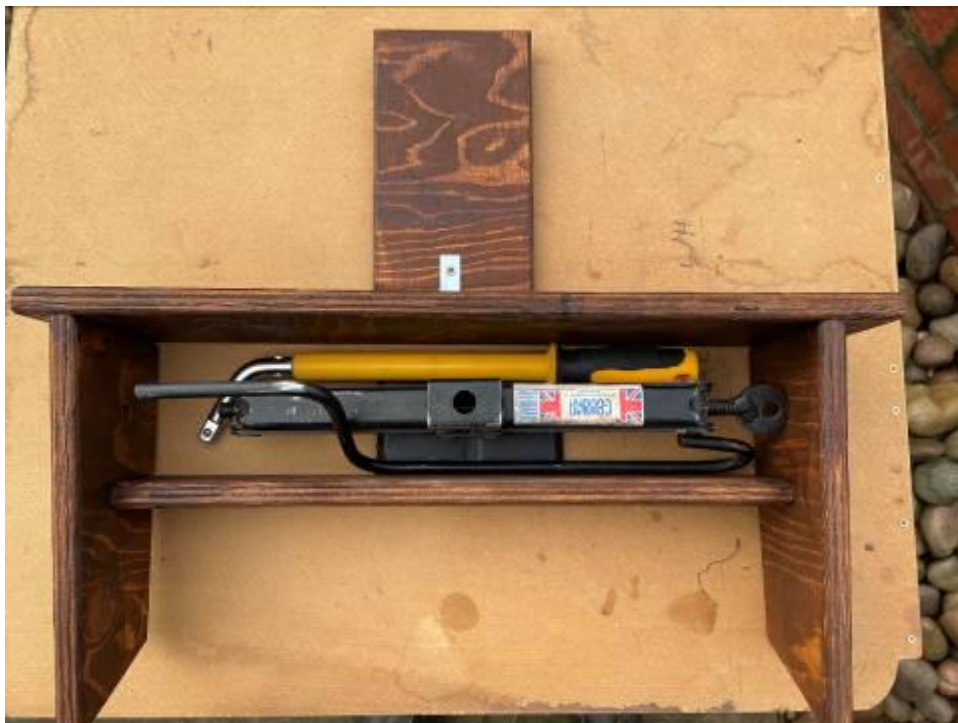
The modified support frame is not fixed in place and just lifts in and out; its purpose is to support the rear section of false floor at its rear end and to act as a divider for parts and tools. The flat section of plywood at the back stops the frame sliding towards the rear of the car.

The modified free-standing support frame.

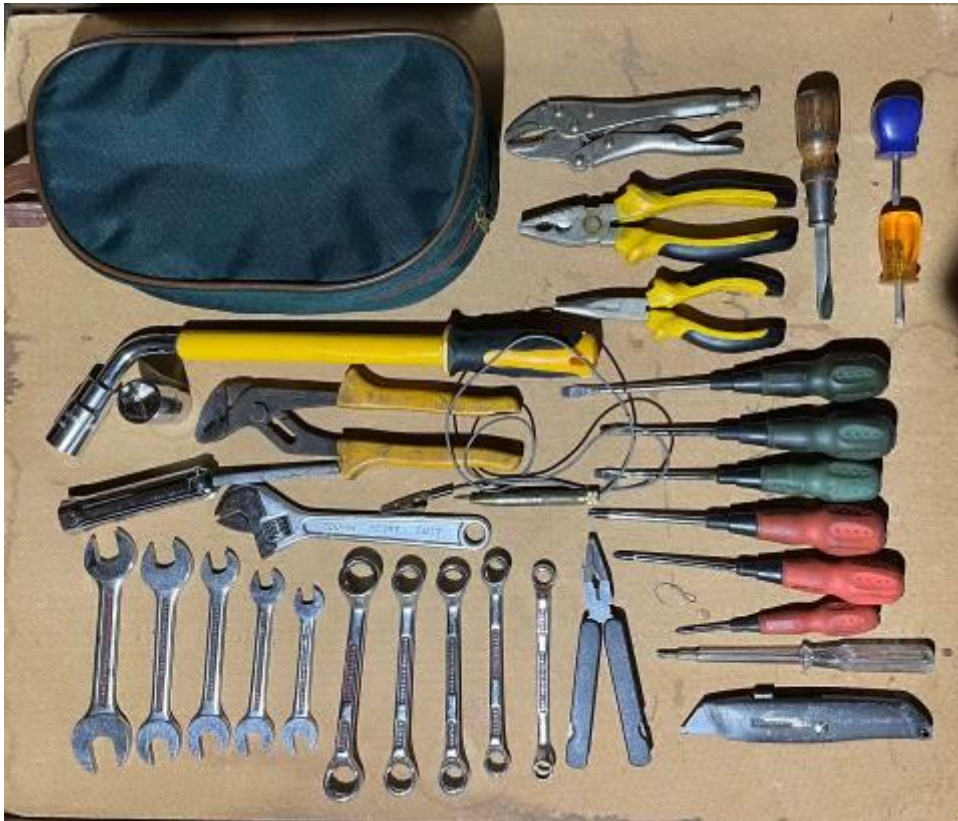
In the mock-up layout photo taken outside the car the spare wheel carrier (borrowed from Rufus the TA) represents the space occupied by the fuel tank filler pipe. With everything fitted in the car the bulb boxes were difficult to access so were re-located to the space just in front of the battery. The duct tape is in their place.

All tools with the exception of the wheel-brace fit in the tool bag.

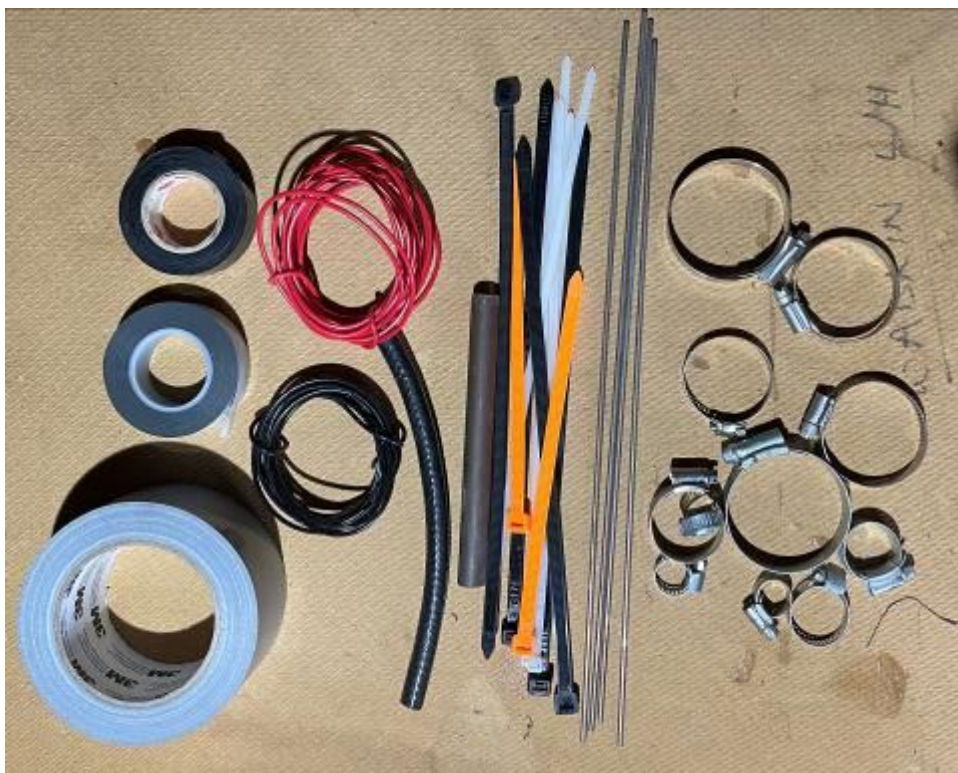
The welding wire and cable ties are located in the jack compartment.

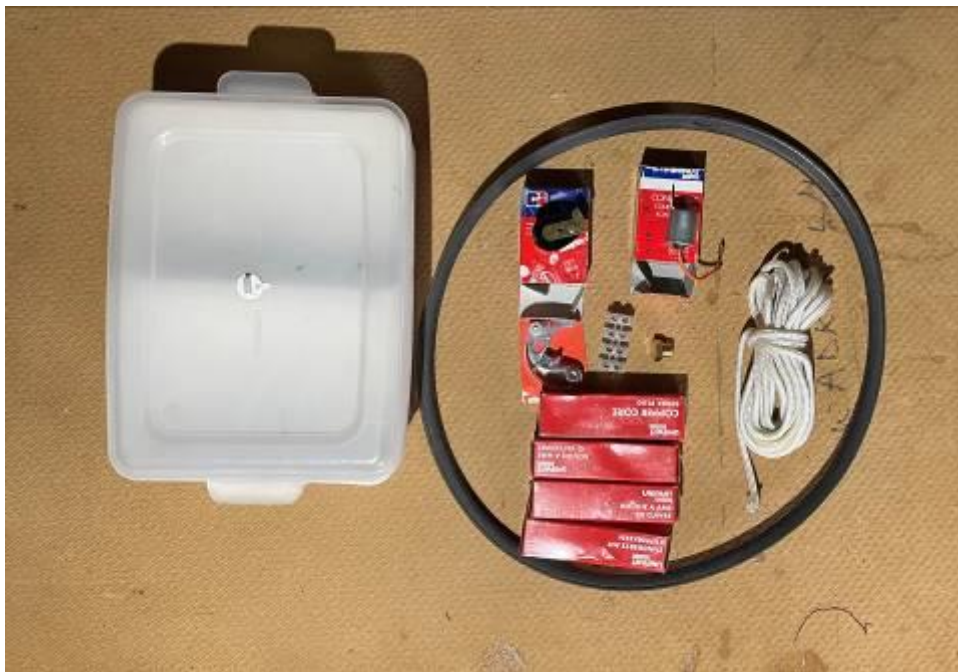
The small parts go in the plastic box.

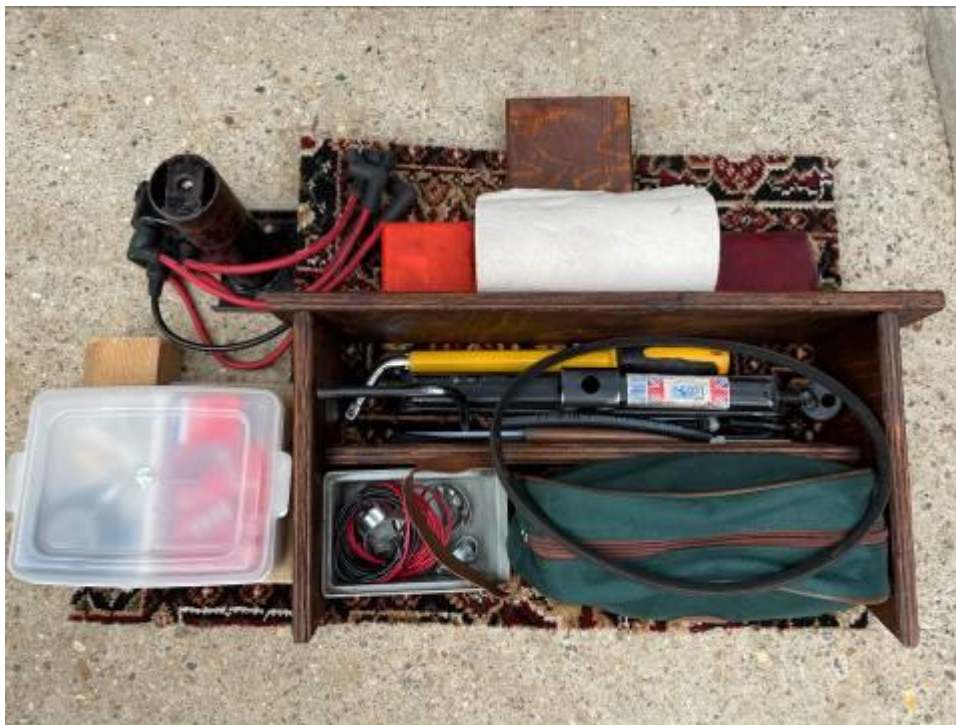
Mock up of location, the distributor cap is an old serviceable one.

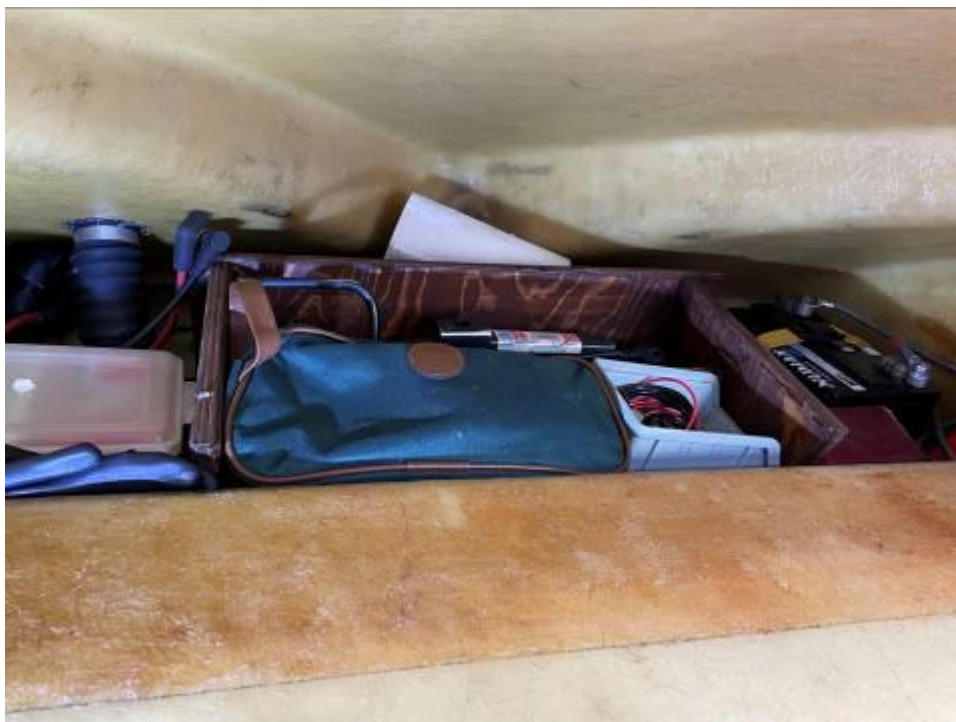
How it all fits in the well, note the gloves in front of the plastic box.

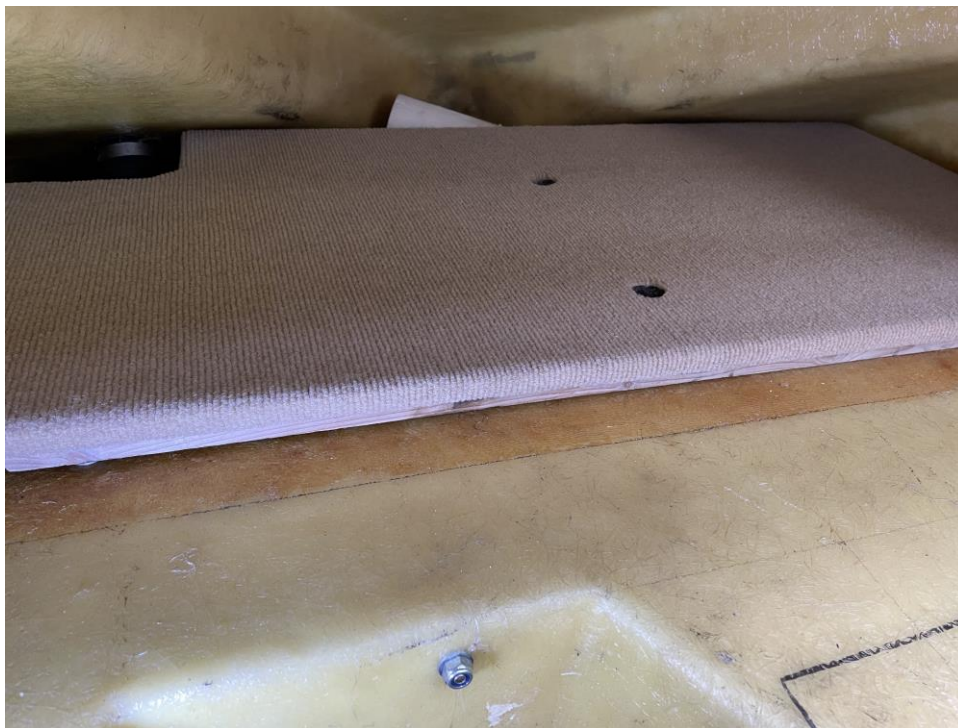
Rear board fitted.

To access the rear well the front edge of the rear floor panel is lifted slightly (easy with the finger-holes) and then slid forward over the front panel. To access the rear 'foot-well' areas the front floor panel is simply lifted up at its forward edge.

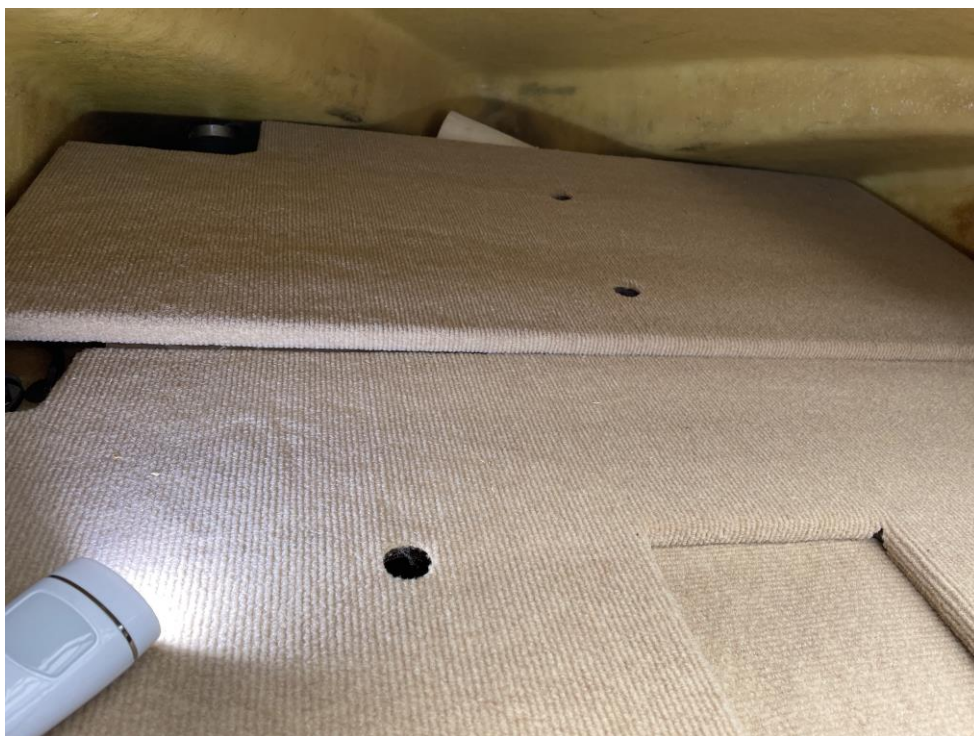
Both boards fitted (The angle of the photo makes it look distorted but it isn't).
